Intel[®] Pentium[®] 4 Processor Specification Update

Release Date: January 2003

Document Number: 249199-031

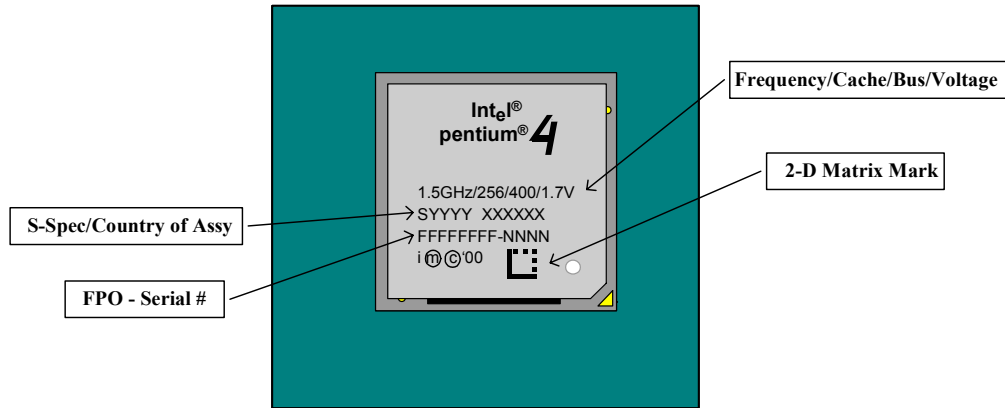
Pentium 4 processor in the 423-pin package and boxed Pentium 4 processor in the 423-pin package markings

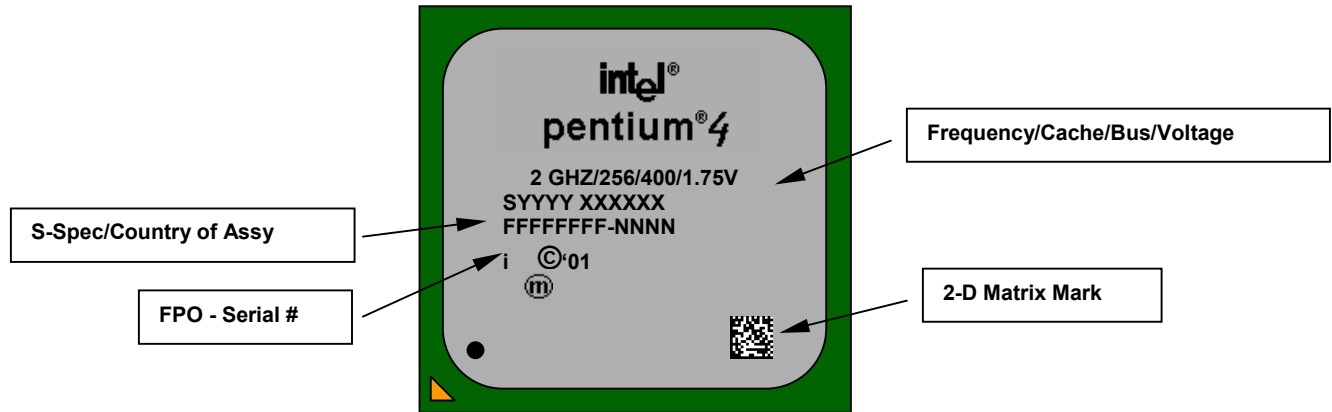
Pentium 4 processor in the 478-pin package and boxed Pentium 4 processor in the 478-pin package markings

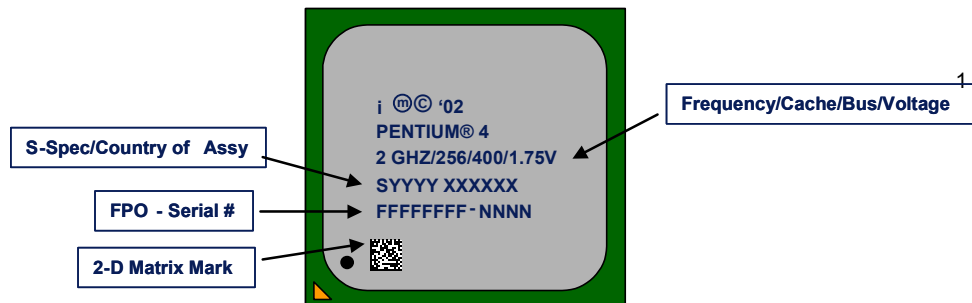
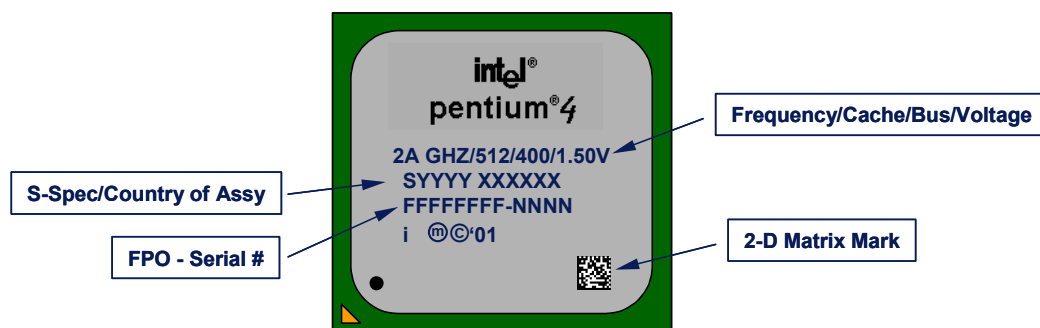
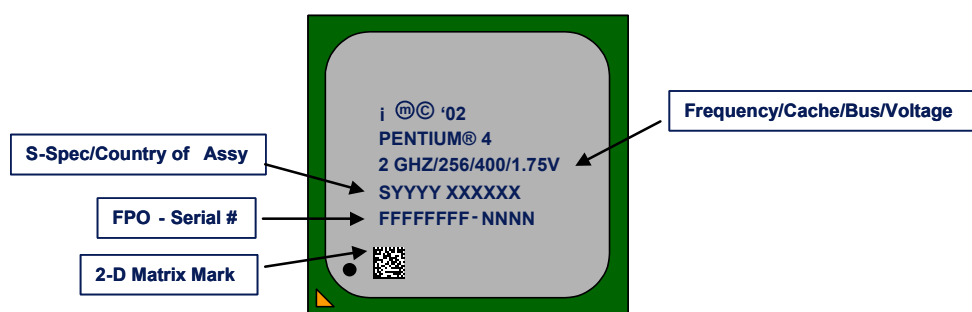
Pentium 4 processor with 512-KB L2 cache on 0.13 micron process and boxed Pentium 4 processor with 512-KB L2 cache on 0.13 micron process processor markings
